**School District**
Security and Safety
Assessment

J&E Consulting Services

June 4, 2013

Conducted May 3rd and 5th

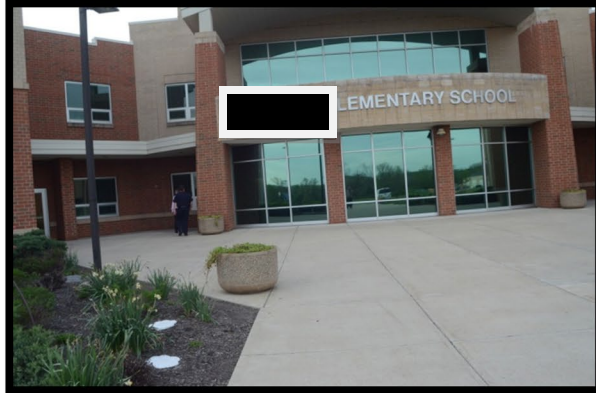
Main entrance to [REDACTED] No barrier to prevent the crashing of a car or truck through the front windows in currently in place..

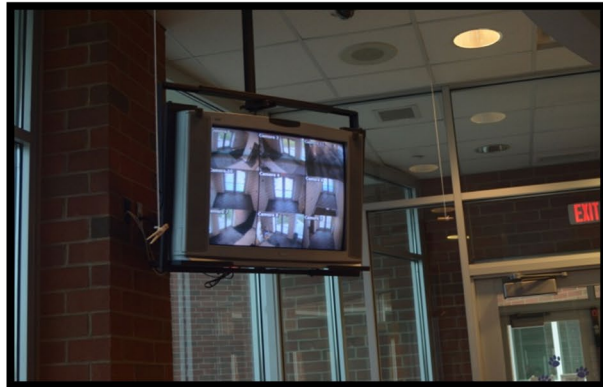
Closed Circuit TV (CCTV) cameras are readily viewed by the receptionist but the cameras are not numbered the same as the doors. Relabeling the cameras to correspond to the actual door number will make identification easier in a critical situation.

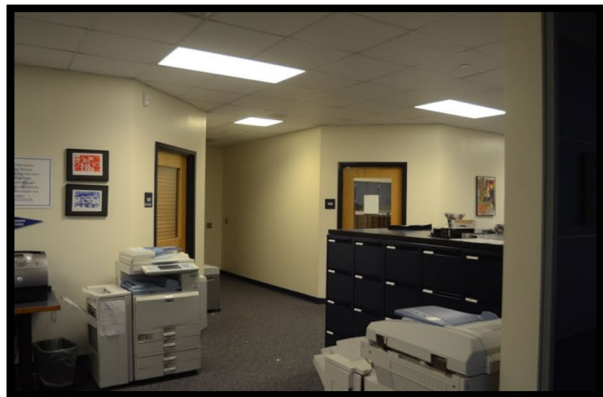
Once entry is gained to the receptionist, full access is granted to an aggressor to the principals offices and to the main school hallways.

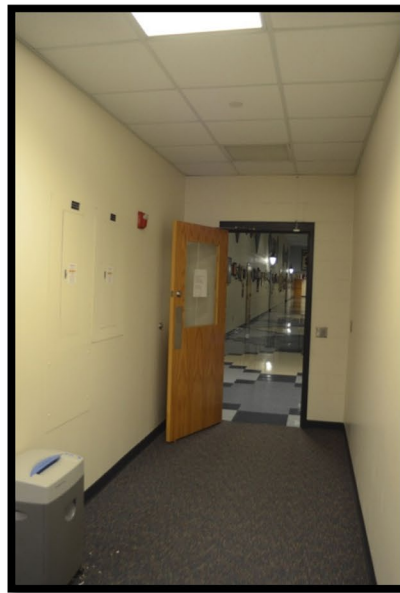
Main entrance door to the school corridors is not secured. This provides access to any person who gets through the front doors.

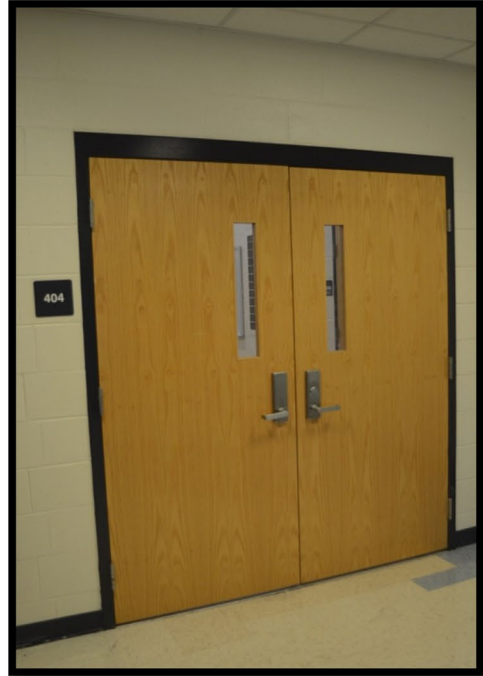
Interior doors currently have dual handles. This permits them to be chained by an aggressor trapping any inside the area. Going to a single door handle would deny this to an aggressor.

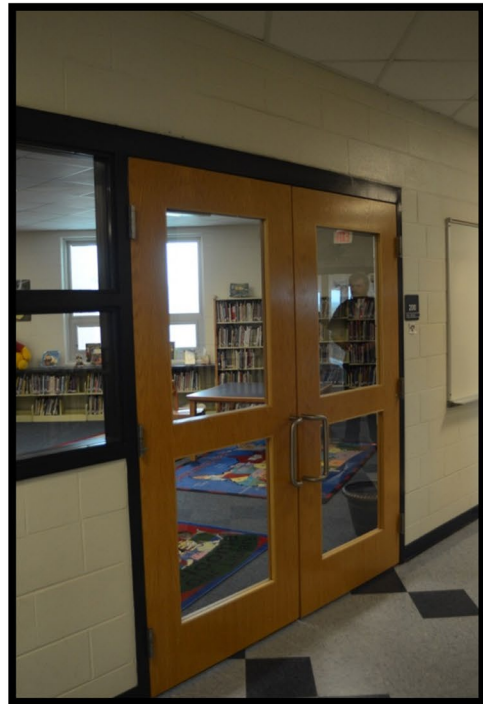
Same issue with a different style door handle.

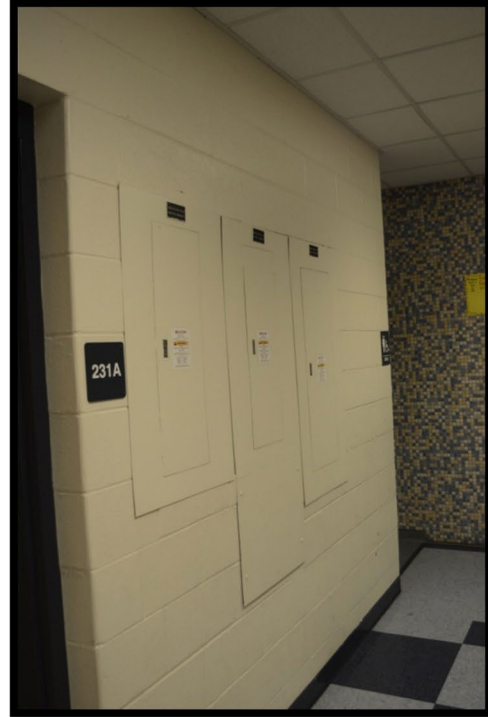
Unlocked electrical panels located in a main hallway area.

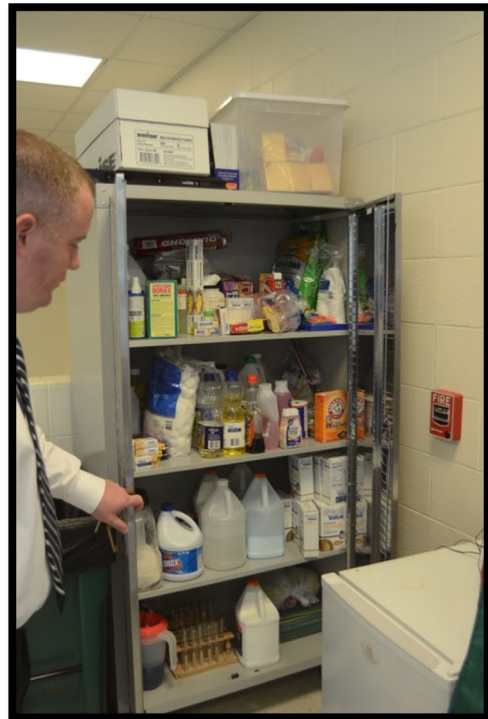
Supply cabinet located in a storage area with the door unlocked for the entrance to the area and the cabinet was also unlocked. Many dangerous chemicals were stored in the cabinet.

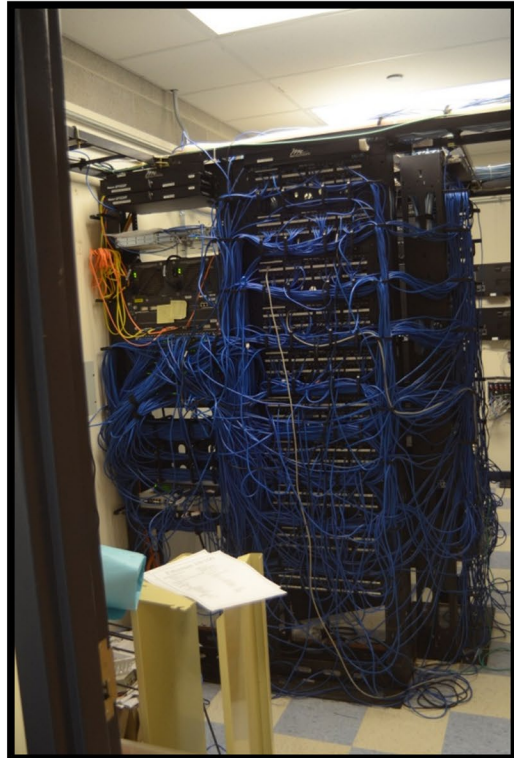
Access doors to the network server area in the library were not locked.

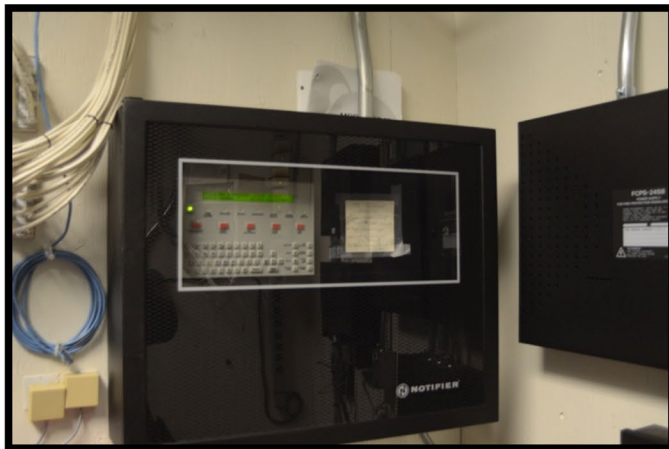
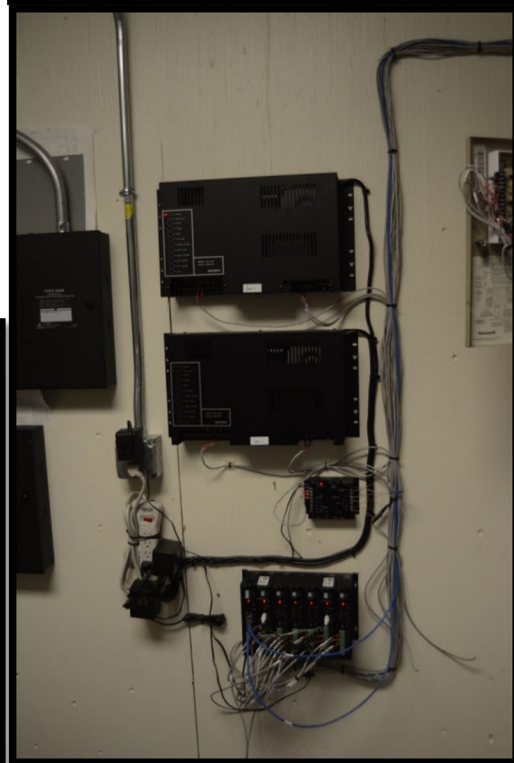
The building alarm system is in the same area and was also not secured.

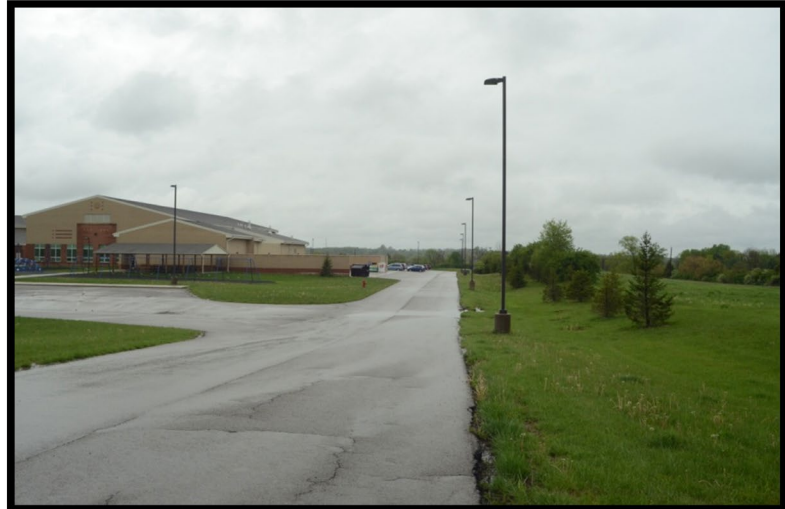
Play areas do not have a well defined boundary the easily keep children away from vehicle access areas.

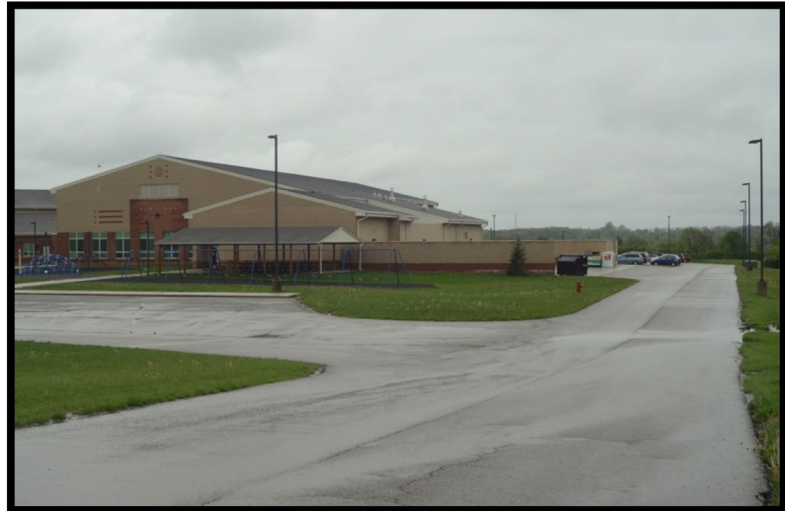
Foliage surrounding the school could easily hide an aggressor or an unauthorized person.

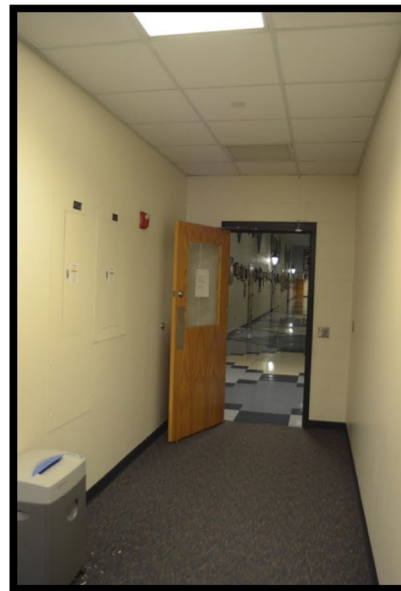
Main entrance door to the school corridors is not secured. This provides access to any person who gets through the front doors.

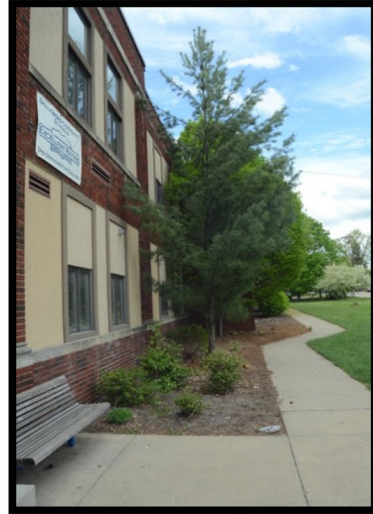
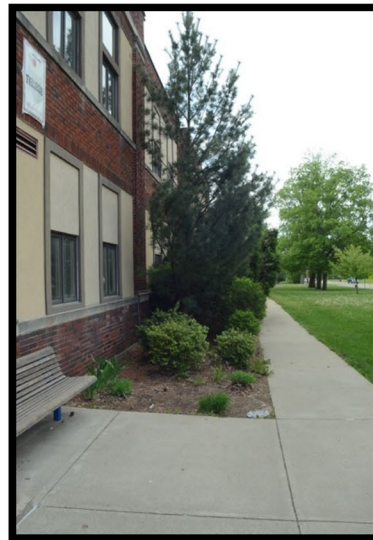
Foliage obscures windows and provides hiding places for intruders or aggressors.

Foliage should be no higher the 3 foot or lower than 8 foot.

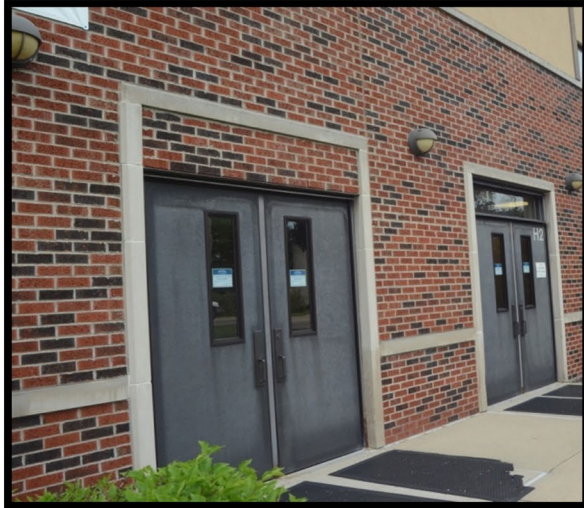
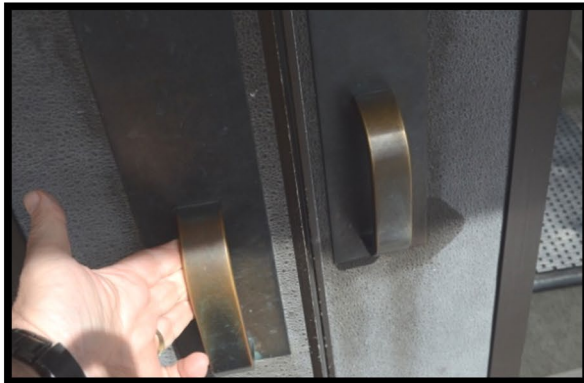
Dual door handles on external doors provide the opportunity for an assailant to chain the doors closed to prohibit exit of teachers and students or entry of first responders. Removal of one or both handles is recommended

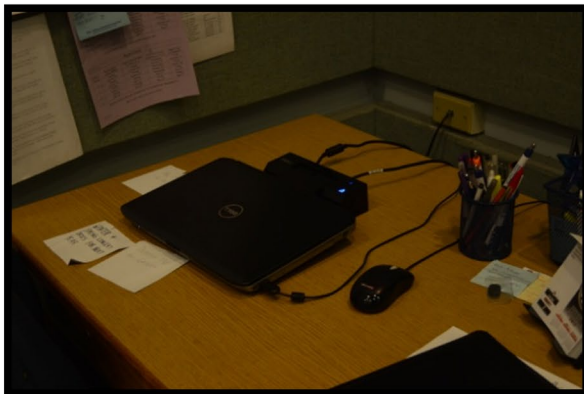
Lap top computers were readily accessible and were not secured to the docking station . The docking was also not secured to any solid feature.

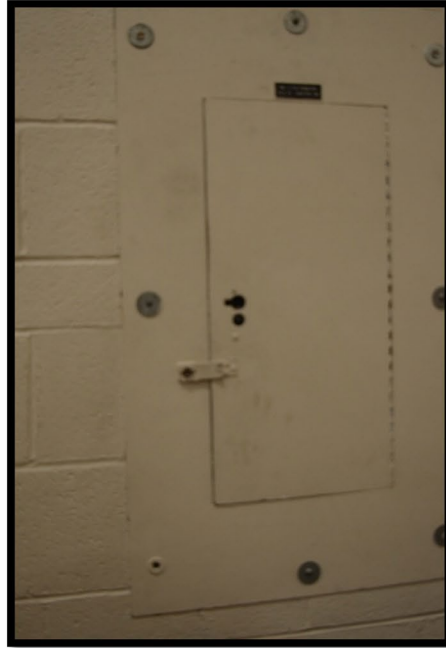
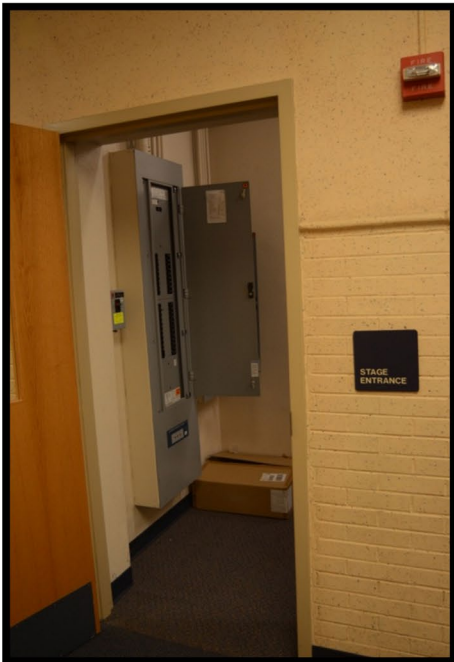
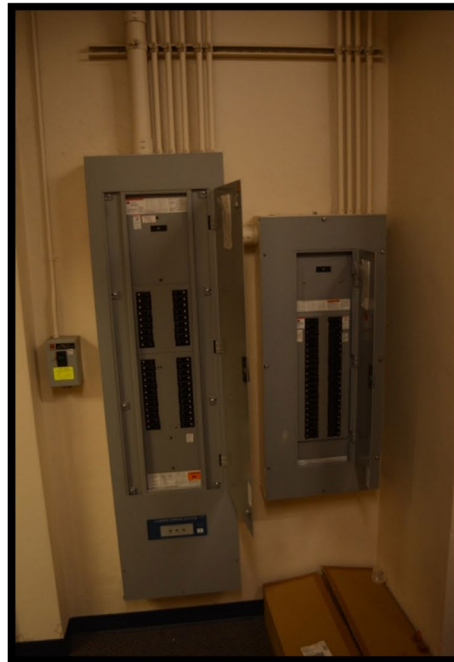
Multiple electrical boxes were accessible to students and most were unlocked.

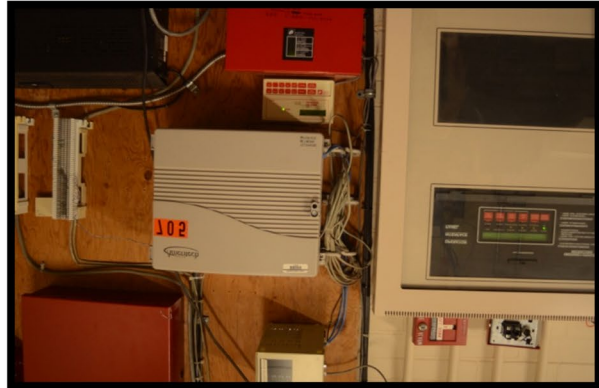
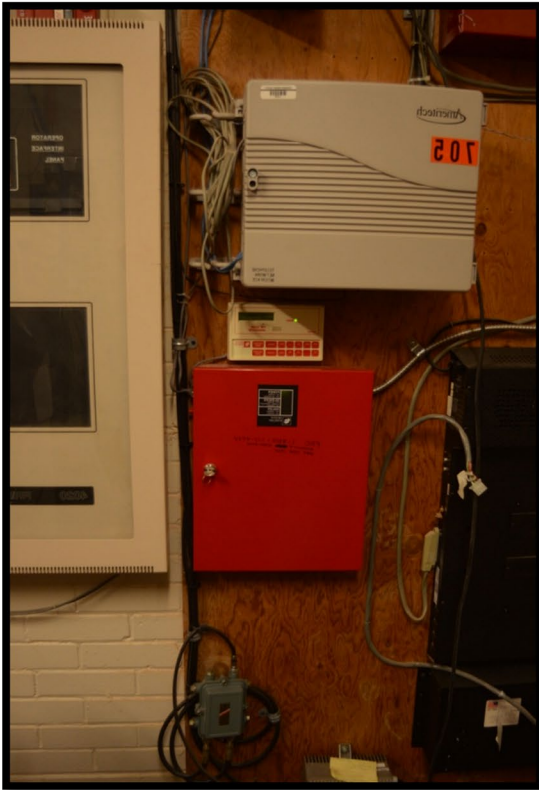
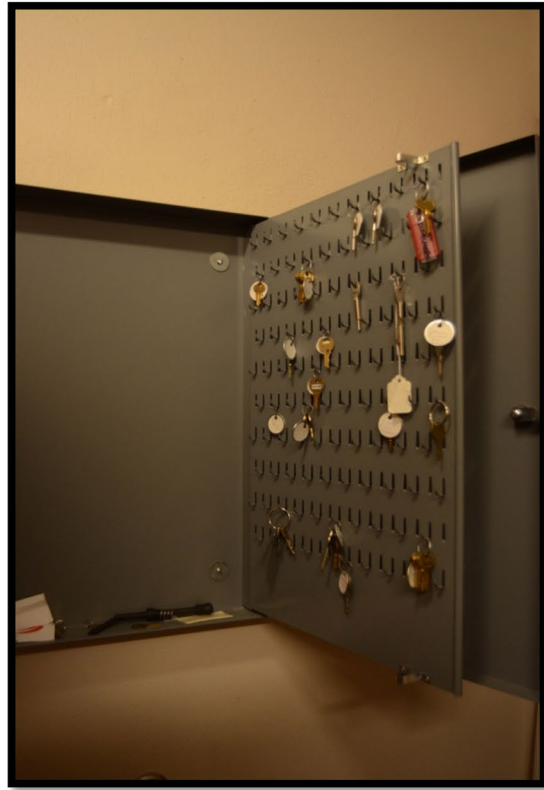
Unlocked key storage and alarm systems in unlocked room. Access to server area was also unsecured.

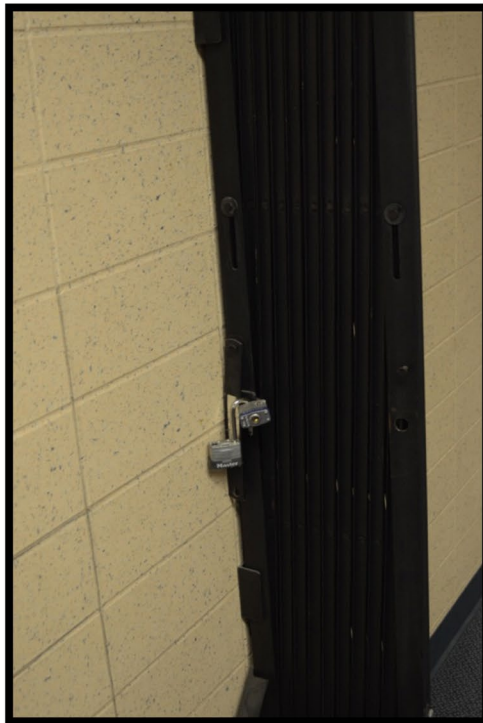
Barriers used to secure areas of the schools during sporting events has open padlocks. This could be used to lock areas by an unauthorized person.

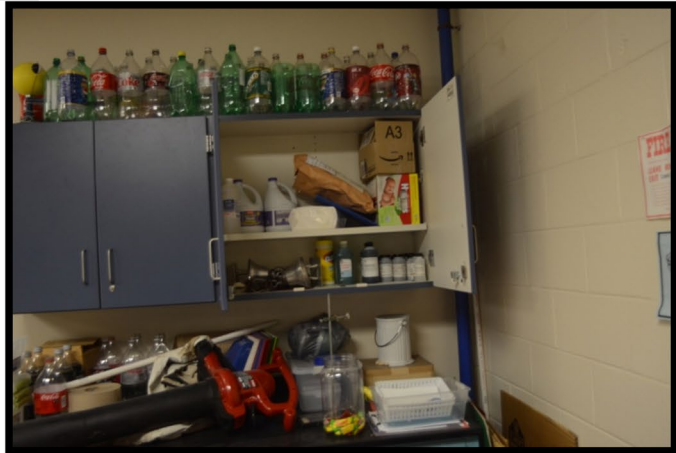
Cabinets for chemicals were found unlocked in unsecured rooms

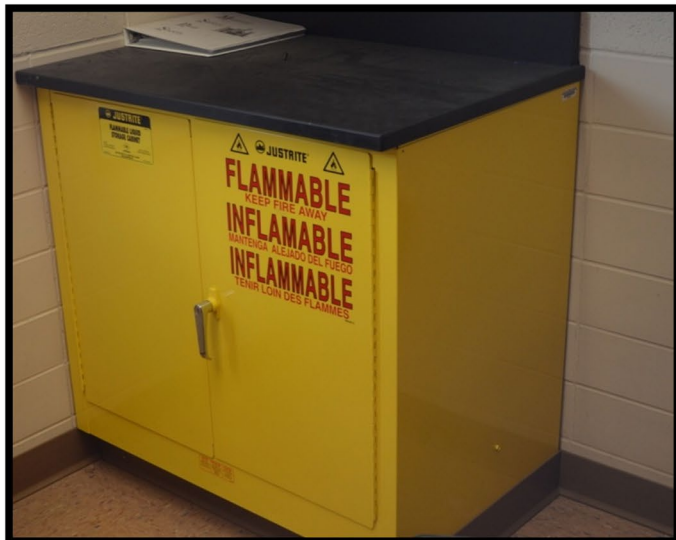
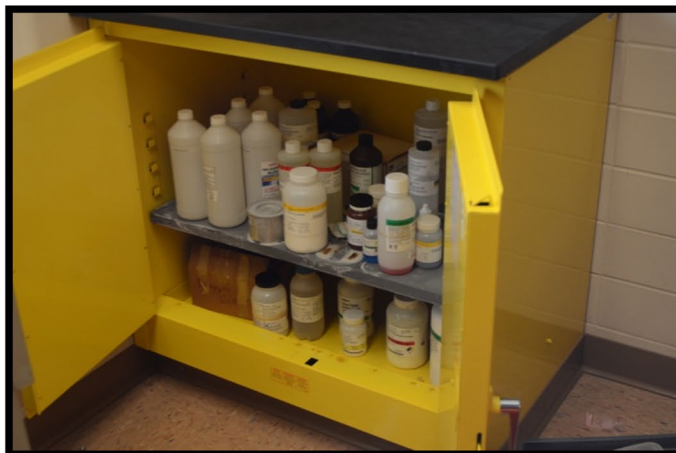
Cabinets for flammable liquids were unlocked in unsecured rooms

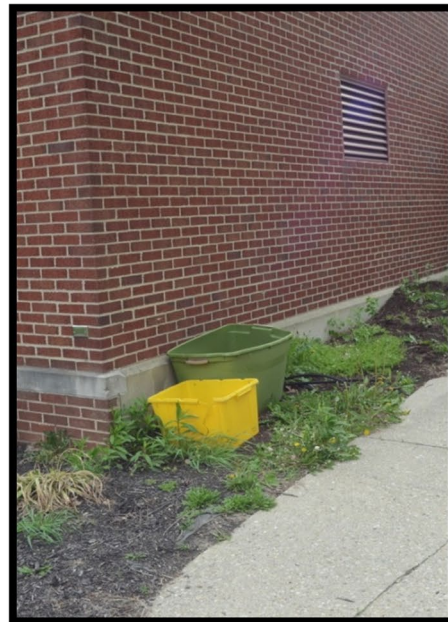
Storage containers located around outside perimeter of the building. This can be used to plant IEDs, Bombs or distraction devices.

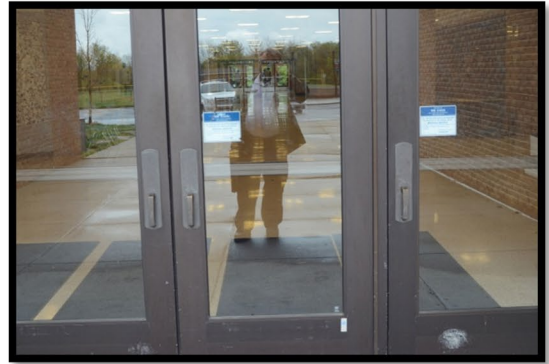
Dual door handles on external doors provide the opportunity for an assailant to chain the doors closed to prohibit exit of teachers and students or entry of first responders. Removal of one or both handles is recommended

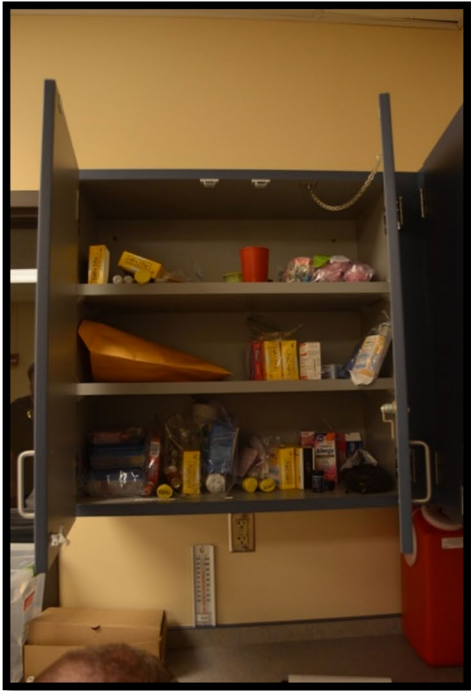
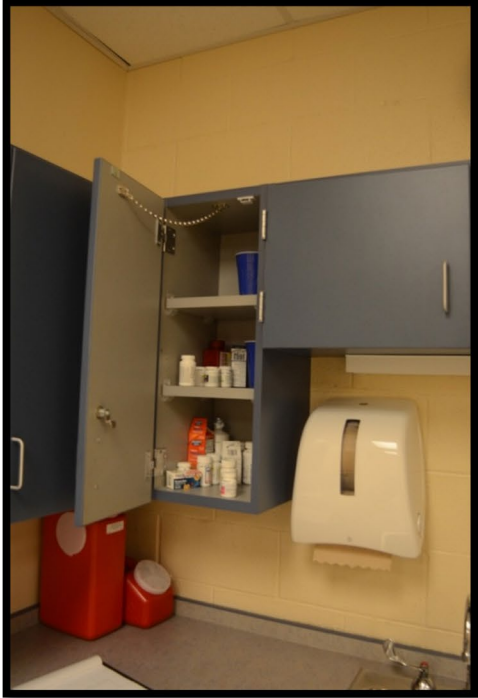
**Entry door to the clinic was unlocked.
Storage cabinets in the clinic for
medical supplies and Over The
Counter Drugs was unlocked.**

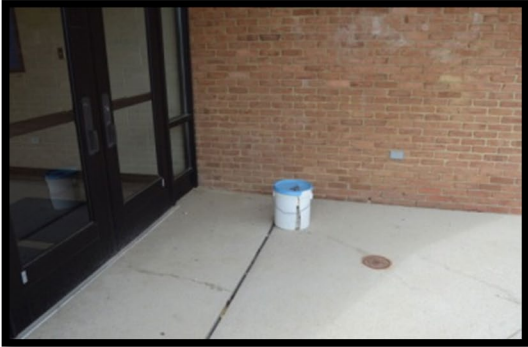
Miscellaneous containers used for trash and as door stops to prop doors open. These may be used to conceal bombs and diversion devices.

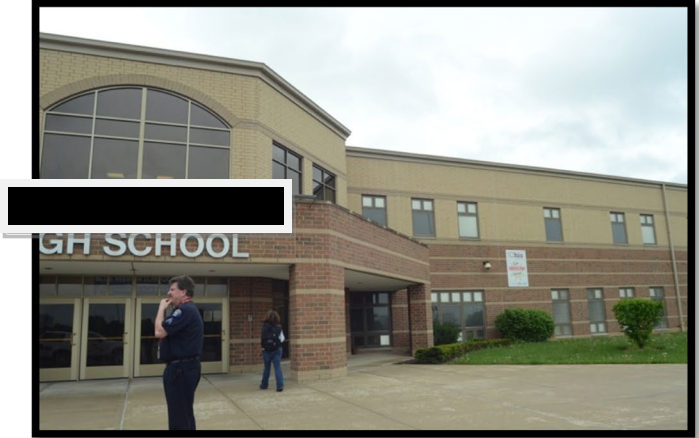
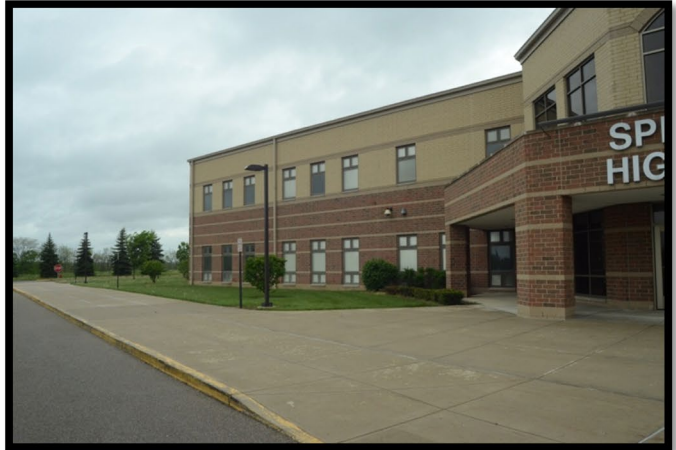
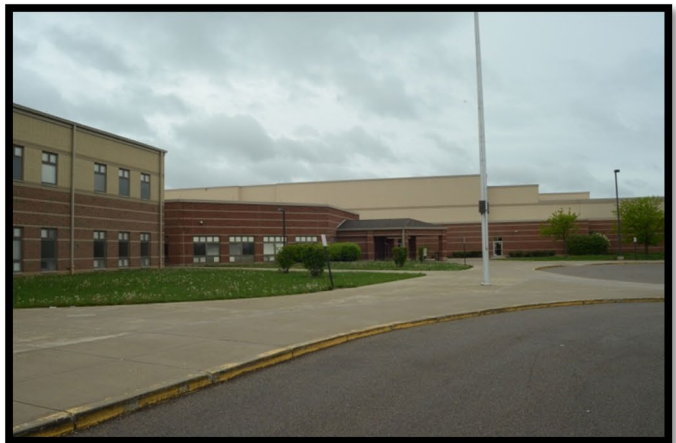
Foliage obscures windows and provides hiding places for intruders. Foliage should be no higher the 3 foot or lower than 8 foot.

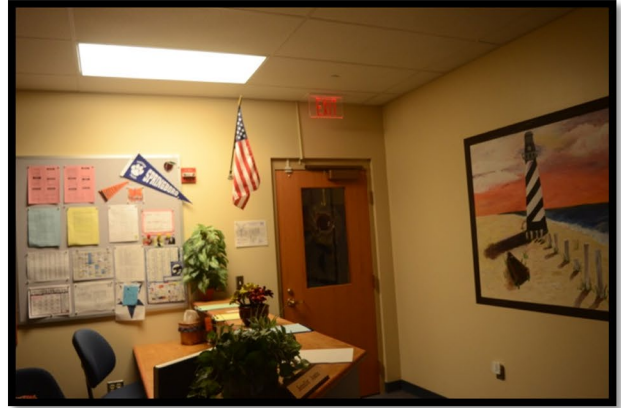
Mag lock is on additional door to school main hallway.

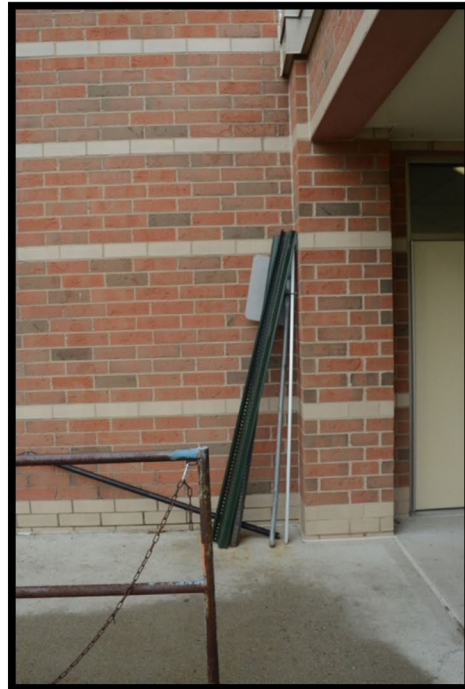
Steel posts left outside the building. These posts can be used as weapons or to break windows for entry to the school.

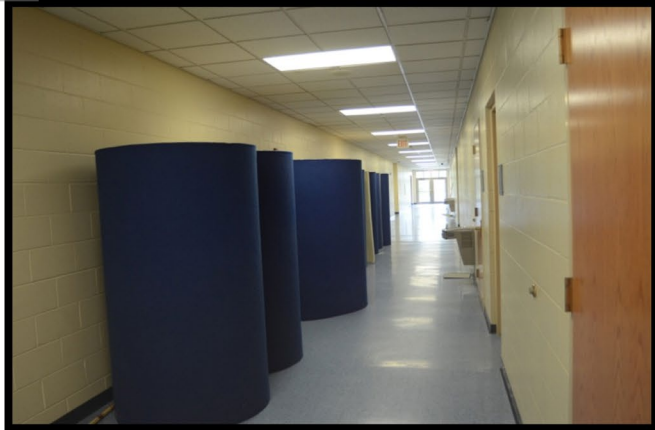
Wrestling mats are stored in main hallway blocking the emergency exit route.

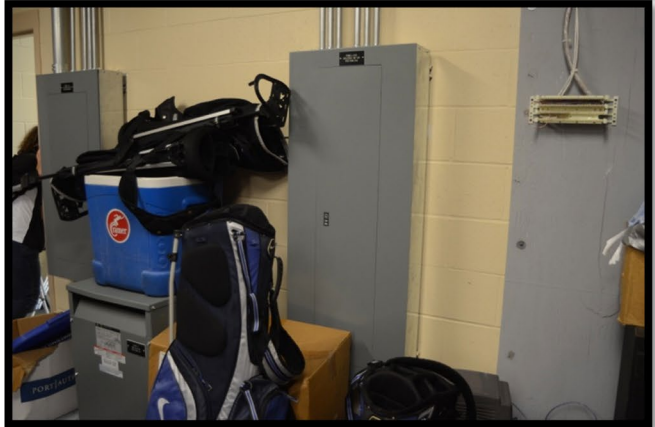
Sports equipment is piled on electrical transformer. Sports equipment is blocking access to electrical panels.

- In the High School, electrical panels in the storage area were obstructed by storied sports equipment.
 - Transformers were obstructed by storied sports equipment.

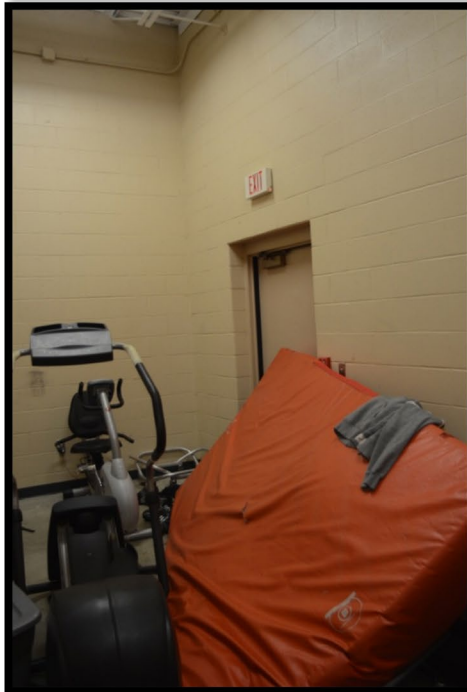
Sports equipment is in front of the emergency exit from the wrestling area.

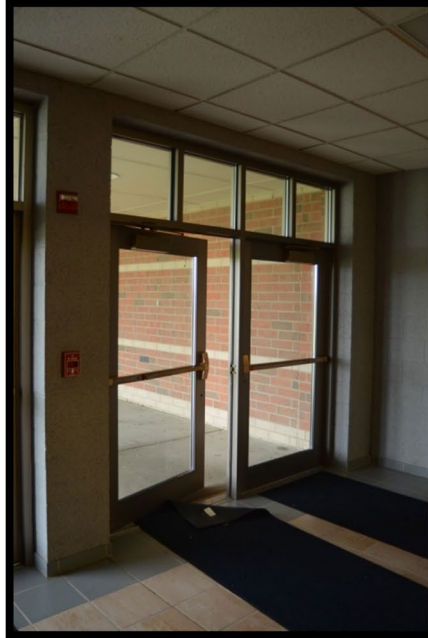
Exterior door is blocked open with floor carpet runner. Open access if permitted.

- **Exterior Doors Unsecured After Hours**
 - A door at [REDACTED] and the JR High were unlocked after all sessions were closed. One door at the High School was propped open with the floor carpet runner.

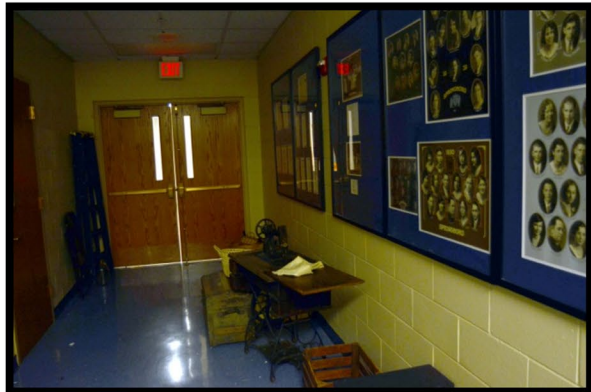
Emergency exit path is blocked with storage materials in art and prop area,

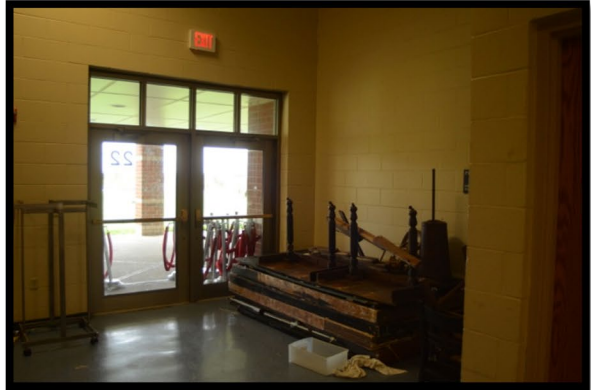
Emergency exit path is blocked with storage materials

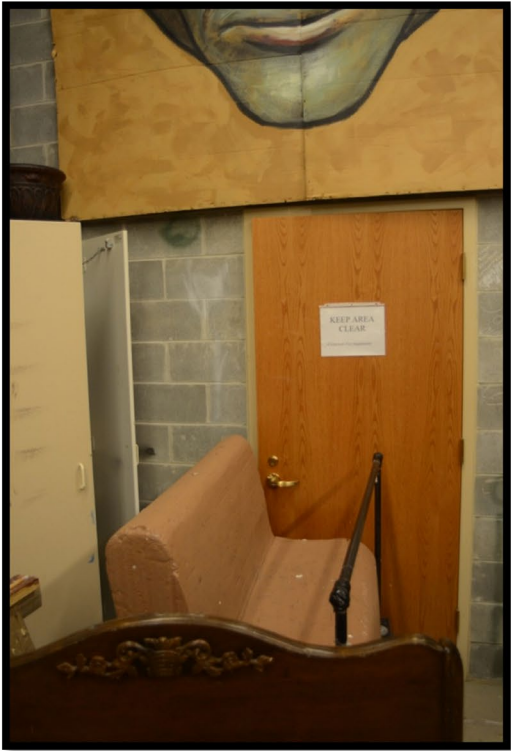
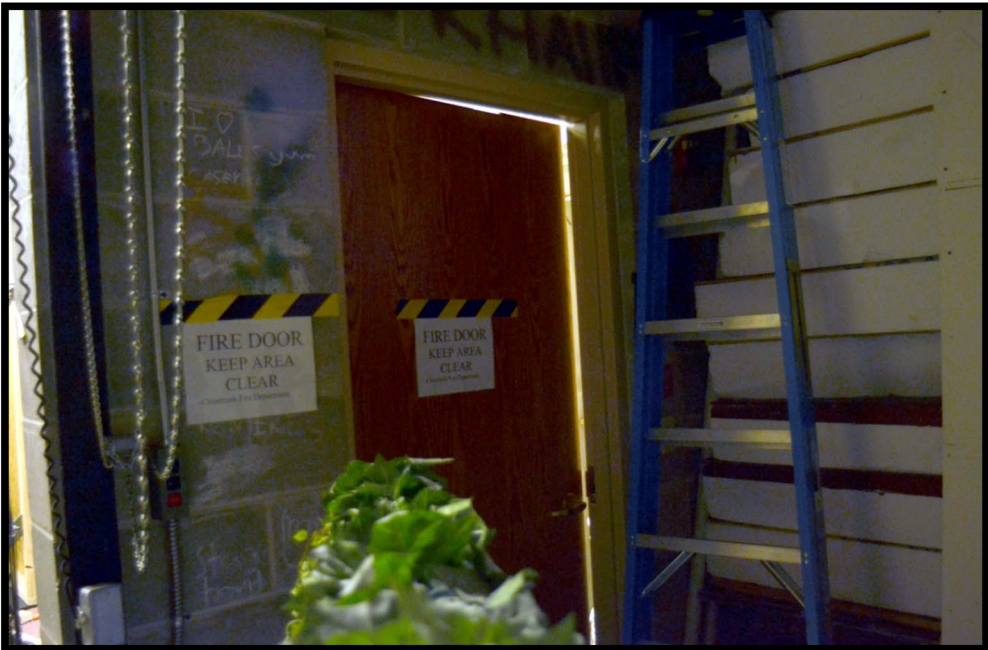
Door posted by Fire Department as required to be kept clear are heavily obstructed.

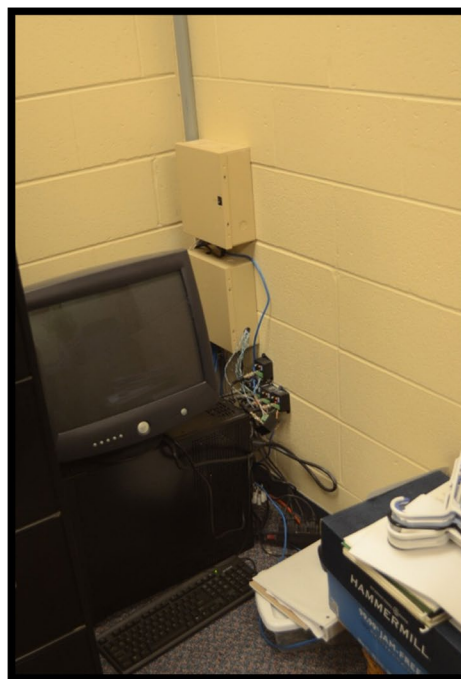
Camera network terminal in band office not secured and available for tampering.

- The CCTV camera junction port in the band office is unsecured and in plain sight for possible tampering.
 - The lock on door E102 seems to be broken and was unsecured. This permits access to the control room for the auditorium and main building electrical cabinets.

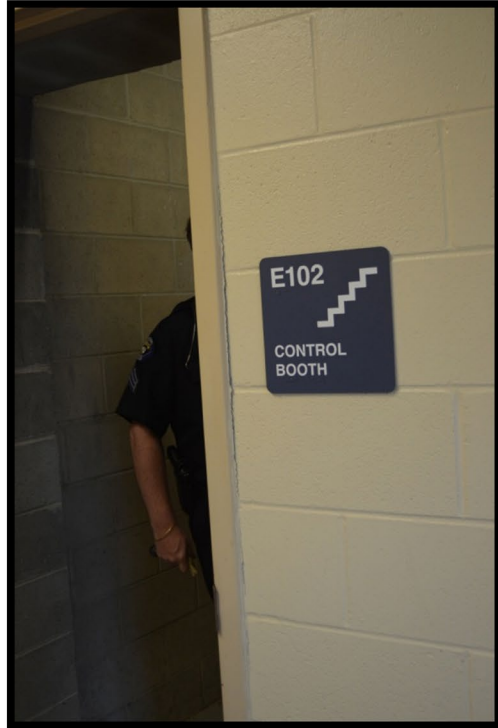
Access door to stage control booth has broken lock and can not be secured. Storage area off of control room is not locked. This provides access to electrical control panels and roof access.

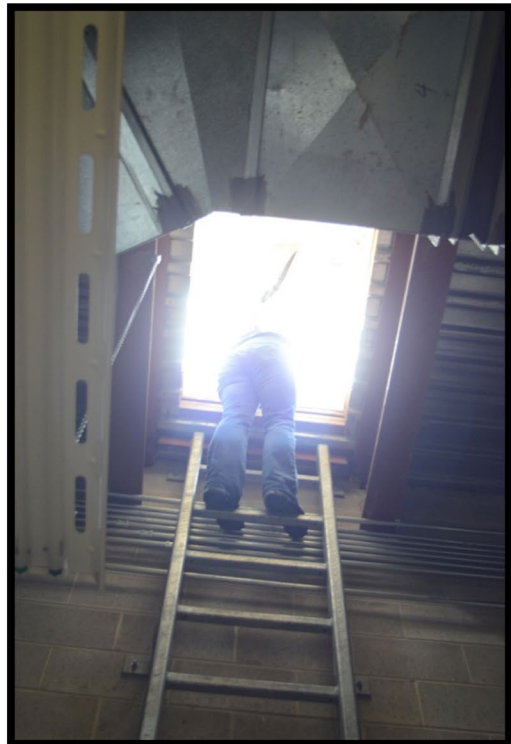
Roof access door is not locked. Free path to the roof is available to students and others.

- Roof access door was unlocked and any student in the area could access the roof.
 - Access to main electrical enclosures this the area was wide open
 - High voltage electrical cabinets were not locked.

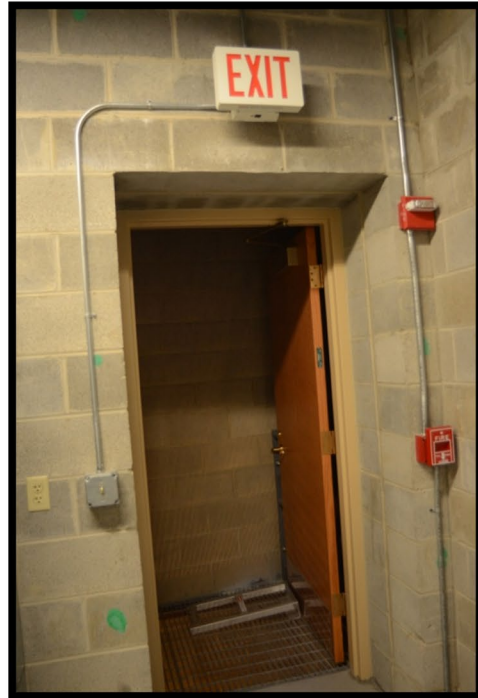
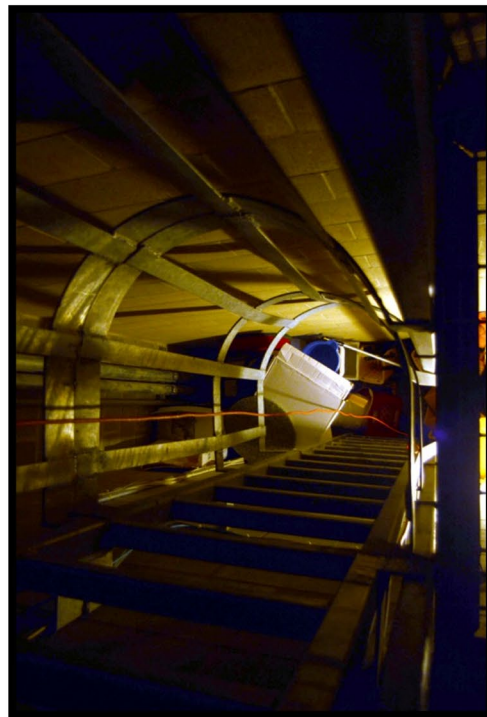
Area at base of service ladder is very cluttered. Large amounts of objects were placed in this area. Door to service ladder is unlocked

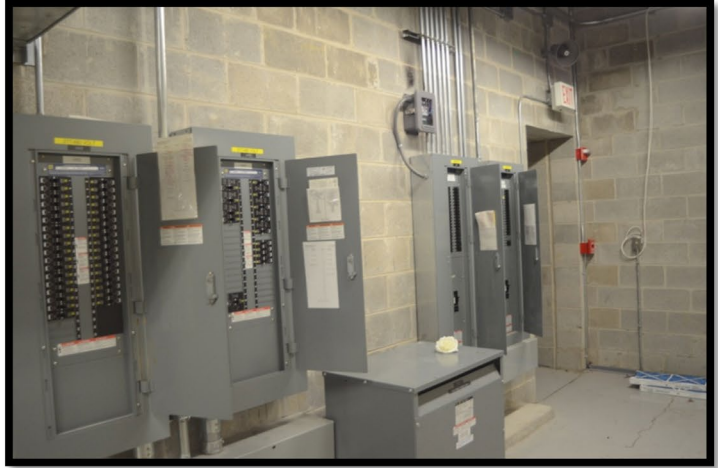
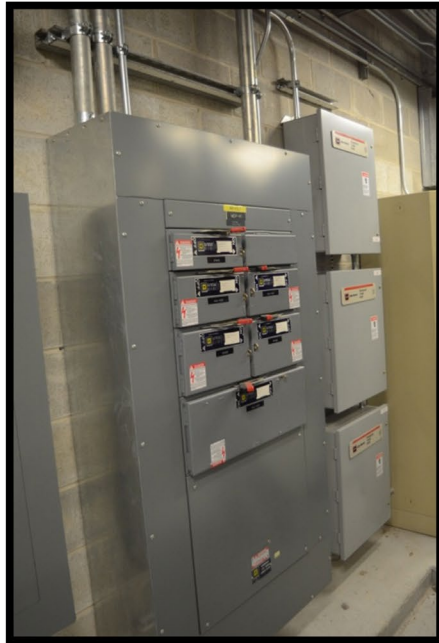
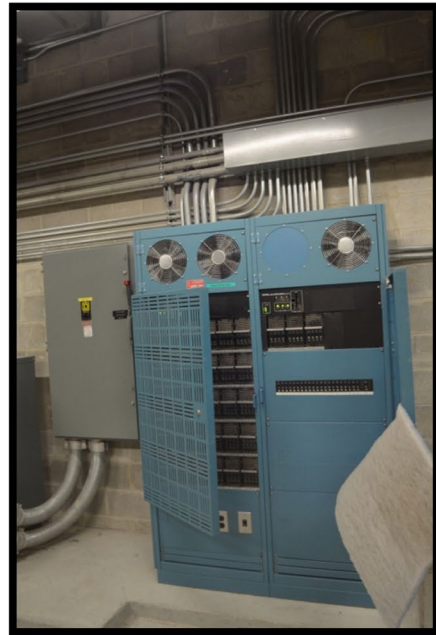
Electrical panels in the service area are not locked. This includes the electrical switch gear units and lighting unit.

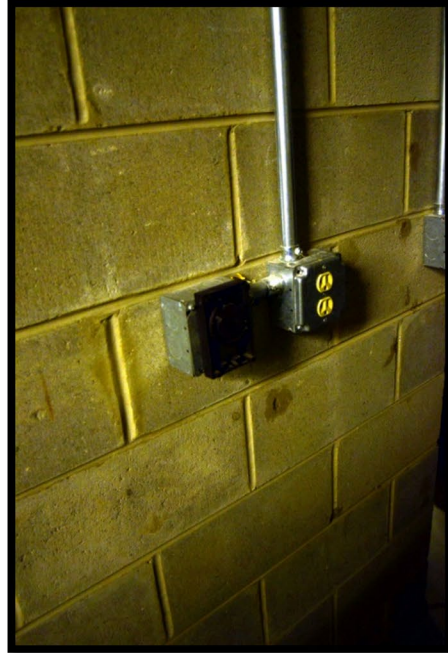
Damage thermostat in control room storage area.

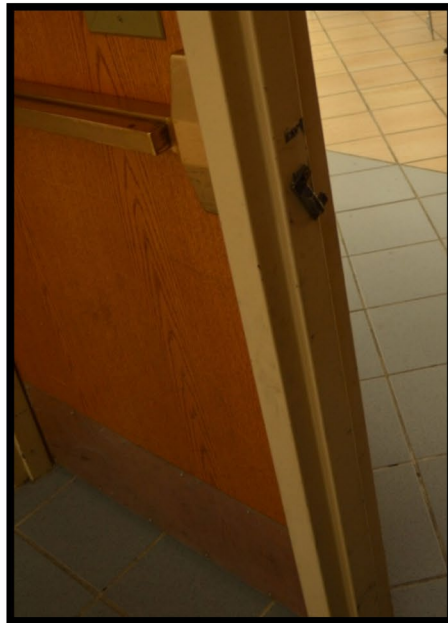
Non functioning door latches in cafeteria.

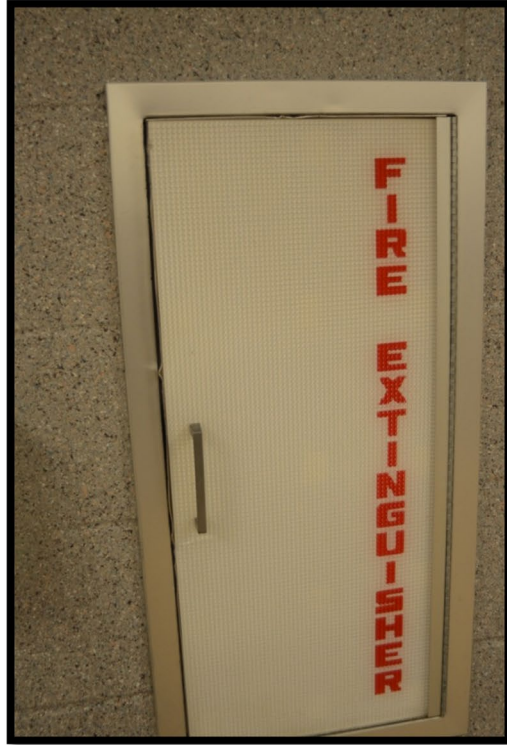
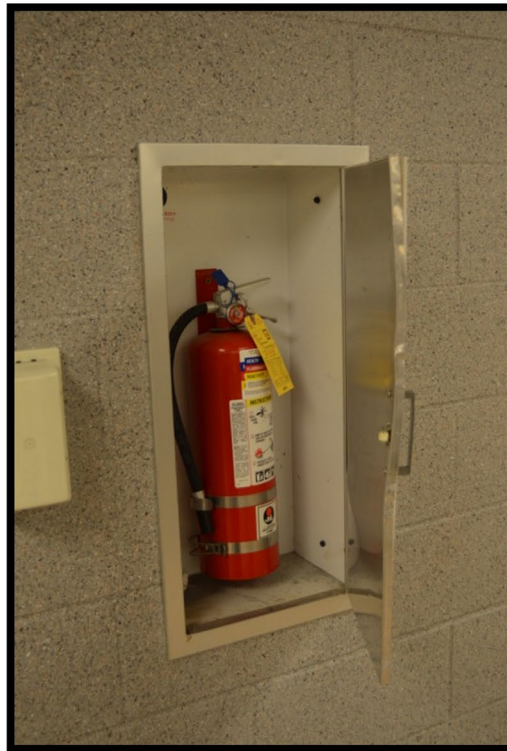
Cafeteria fire extinguisher storage cabinet is damaged. It had to be pried with a screwdriver to open the door to gain access to the extinguisher. In an emergency, this unit may not have been available.

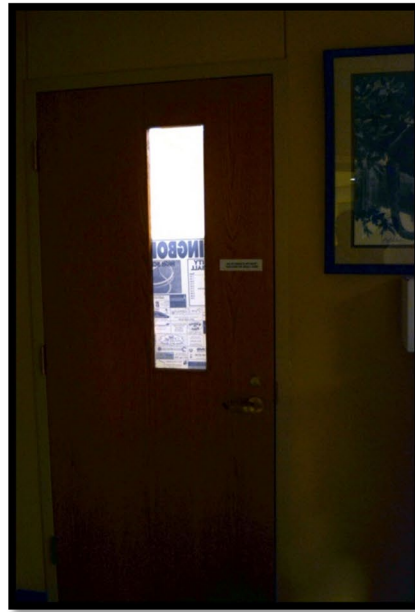
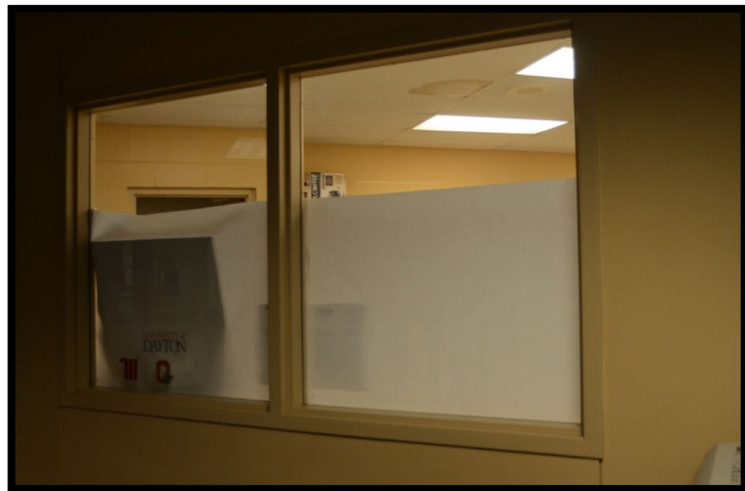
Several windows in offices and work areas are obscured. This prevents observation of prohibited activities.

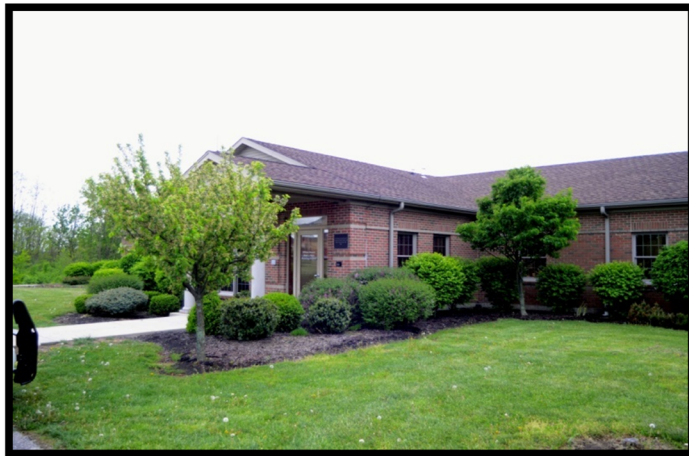
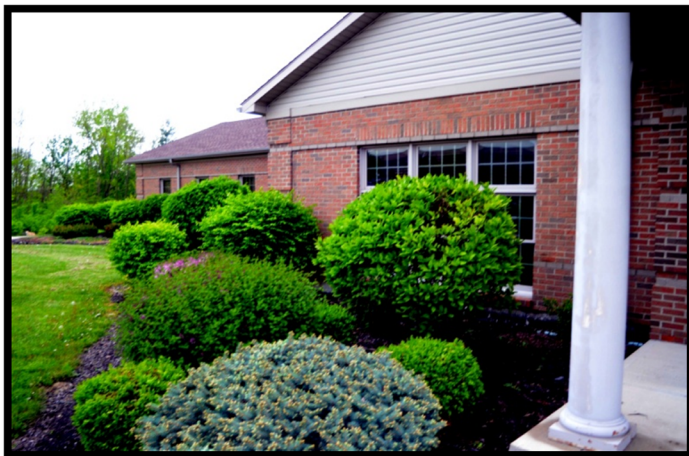
Foliage obscures windows and provides hiding places for intruders or aggressors.

Foliage should be no higher than 3 feet or lower than 8 feet.

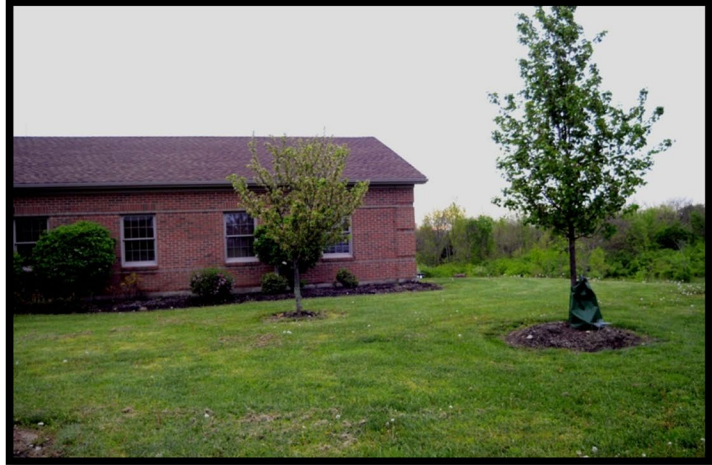
Foliage obscures windows and provides hiding places for intruders. Foliage should be no higher than 3 feet or lower than 8 feet.

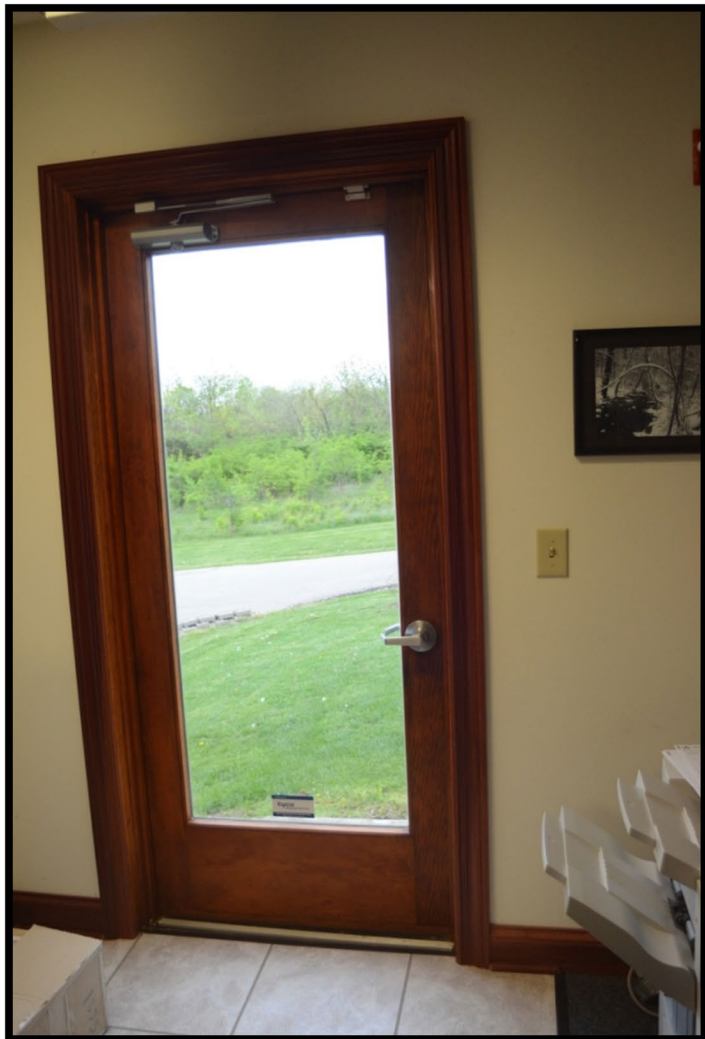
Exterior access door at each end of the facility has tall windows. Not providing has been made to reduce view from outside if needed. Glass is also very easy to break to gain entry into the facility.
